## DEVELOPMENT OF A NUMERICAL MODEL OF A HYPERVELOCITY IMPACT INTO A PRESSURIZED COMPOSITE OVERWRAPPED PRESSURE VESSEL

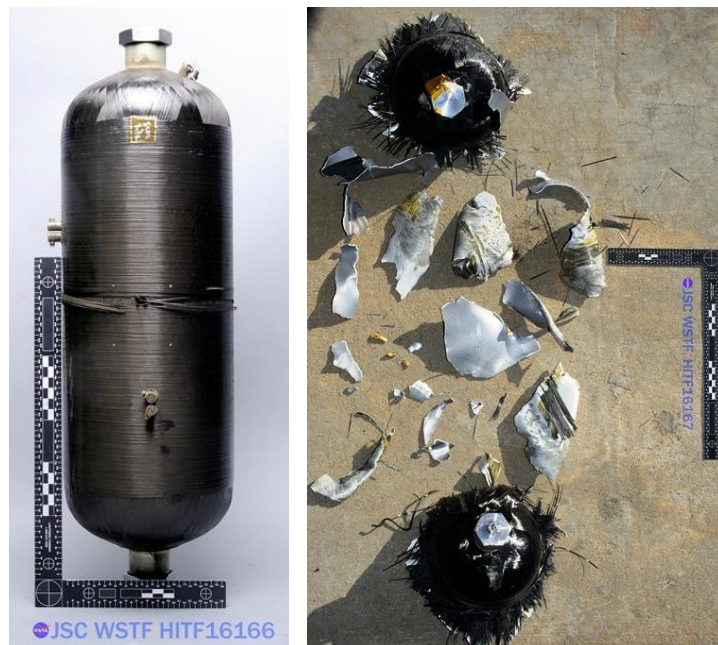
For the unpressurized COPV, the dependence of penetration up to the dependence of hole size in the liner has been obtained as a function of impact conditions. For the pressurized research, the dependence of penetration up to rupture has been obtained as a function of impact conditions. Two representative post-test photographs of the failed COPV's from a normal impact into the COPV surface are shown in Fig. 1. These images display the dramatic difference between failure modes, venting (Fig. 1a) and rupture (Fig. 1b). For venting, liner perforation, severed composite fibers/tows and ply delamination are commonly observed damage characteristics of this COPV failure mode. In the case of rupture, the COPV typically experienced a separation of its domed regions and severe break-up of the cylindrical region.

Fig. 1. Post test photo-documentation of observed failure modes: a) Perforation resulting in venting. b) Remnants of a ruptured COPV due to impact.

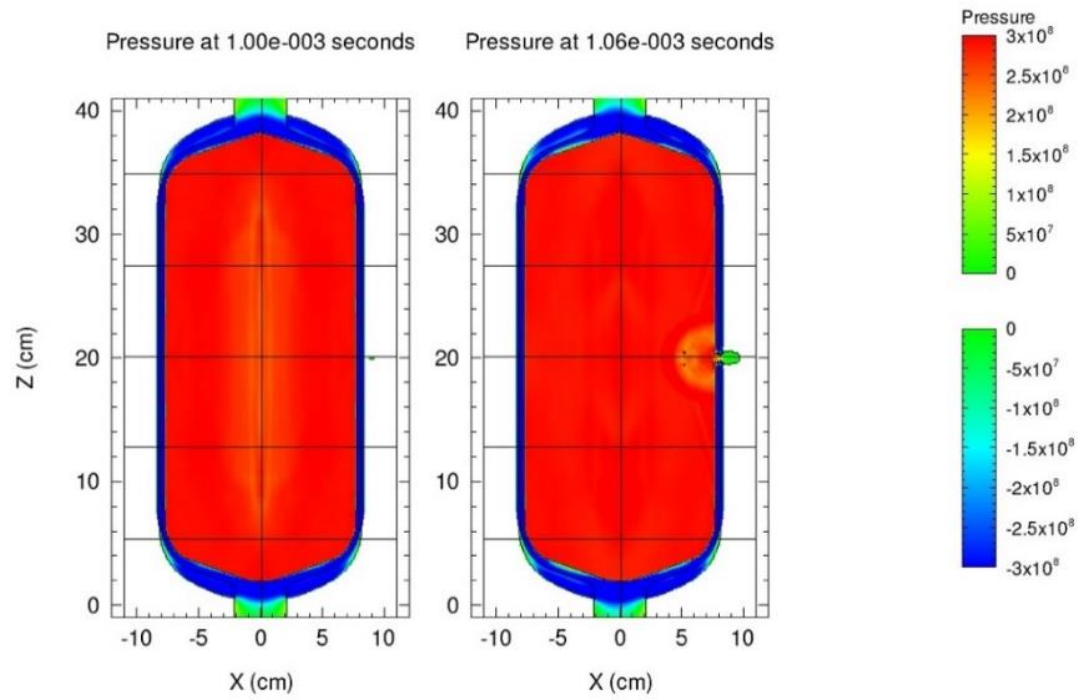
A typical pressure contour plot from an impact simulation of an entire COPV is shown in Fig. 2. To generate the COPV stress state without initiating a shock wave, the pressure in the simulated COPV is ramped up to the final pressure over a millisecond prior to impact of the projectile with nitrogen gas. Figure 2a shows the system in this initial condition. After one millisecond, a projectile is initiated into the simulation and impacts the COPV. Figure 2b shows the system after this impact. In the figure, the onset of venting is represented as

the change in pressure ( $\mu\text{bar}$ ), red to green, at the perforation site. Also seen in the figure is the eroded projectile that had passed into the COPV vessel with the generated shock wave in the pressurant propagating just ahead of the material.

Fig. 2 a) Cross section of pressurized COPV model prior to hypervelocity impact. b) Post-impact showing perforation, venting, projectile erosion and shock wave propagation..
